PROBLEM: Receiver noise raises when the repeater antenna is connected !

Here are the e-mail exchanges I had with Carl (name fictive) regarding this problem. Many areas for solutions have been explored. I feel it might help other people that have similar problems. Jacques VE2AZX ve2azx.net

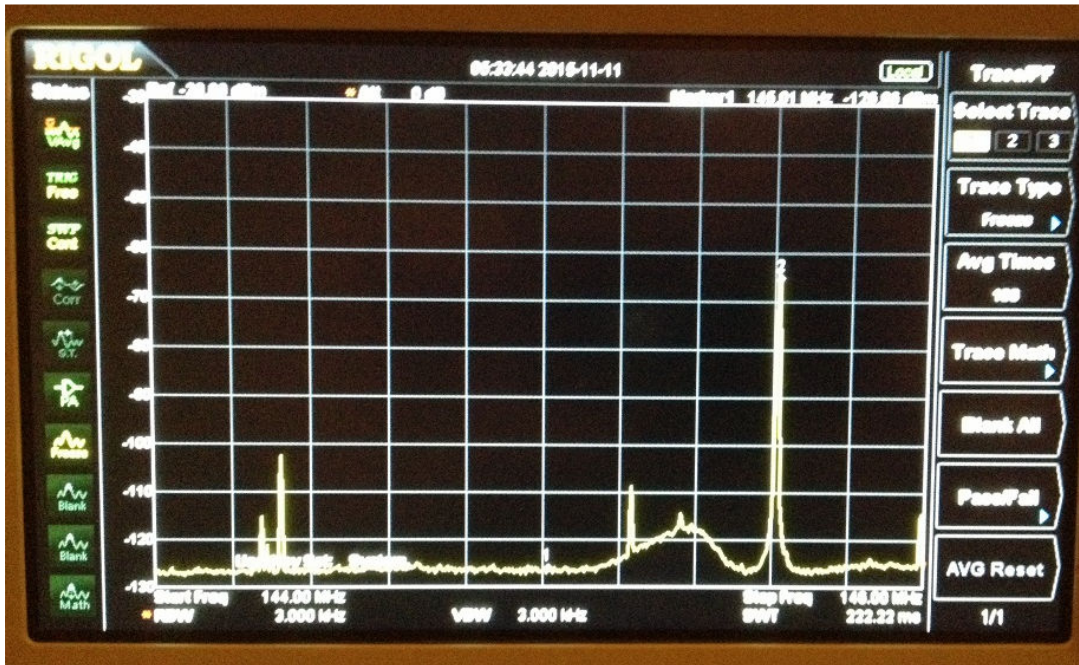
DummyLoad-TXON.JPG:

If I use a dummy load, everything is fine. You see the TX signal on the right (at "Marker2", 145.6125 MHz), well attenuated to about -64 dBm. Next to the left, you see part of the phase noise of the TX signal, which gets well attenuated when it comes to the RX frequency (at "Marker1", 145.0125 MHz). (Center Frequency is 145.0000 MHz)

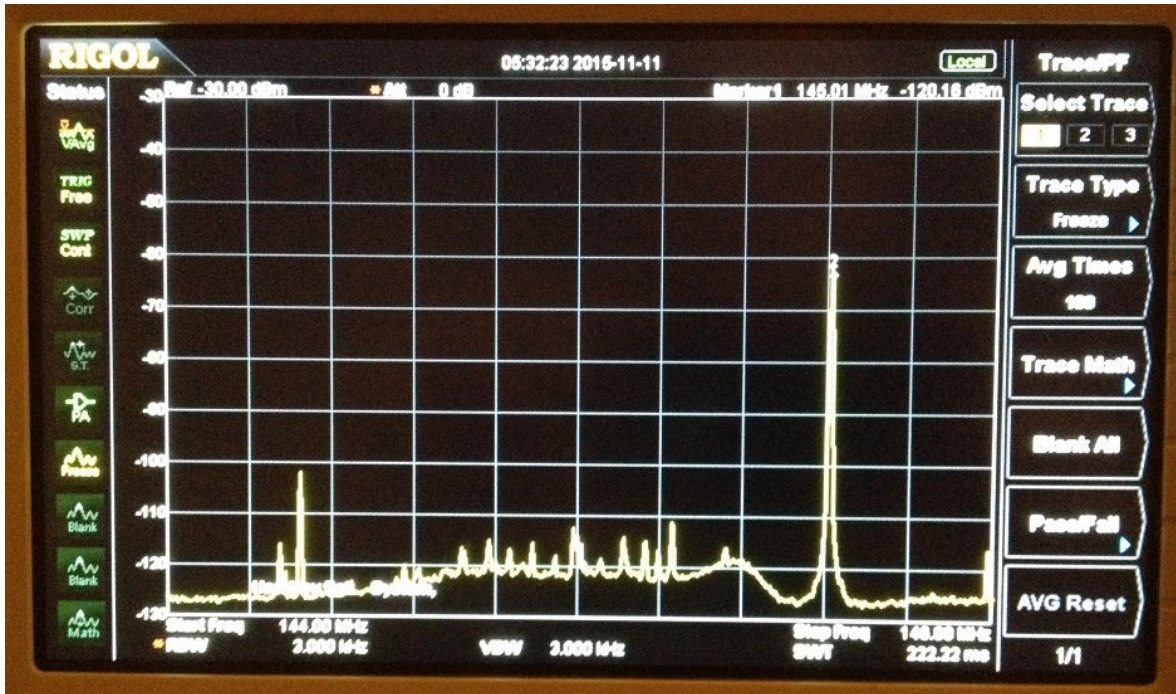
Antenna-TXON.JPG:

If I then attach the antenna, things get worse. The noise floor rises from 144.4000 to about 145.2500, and you see some peaks. These peaks are always at the same frequency. But they are not carriers, they are kind of noise accumulations.

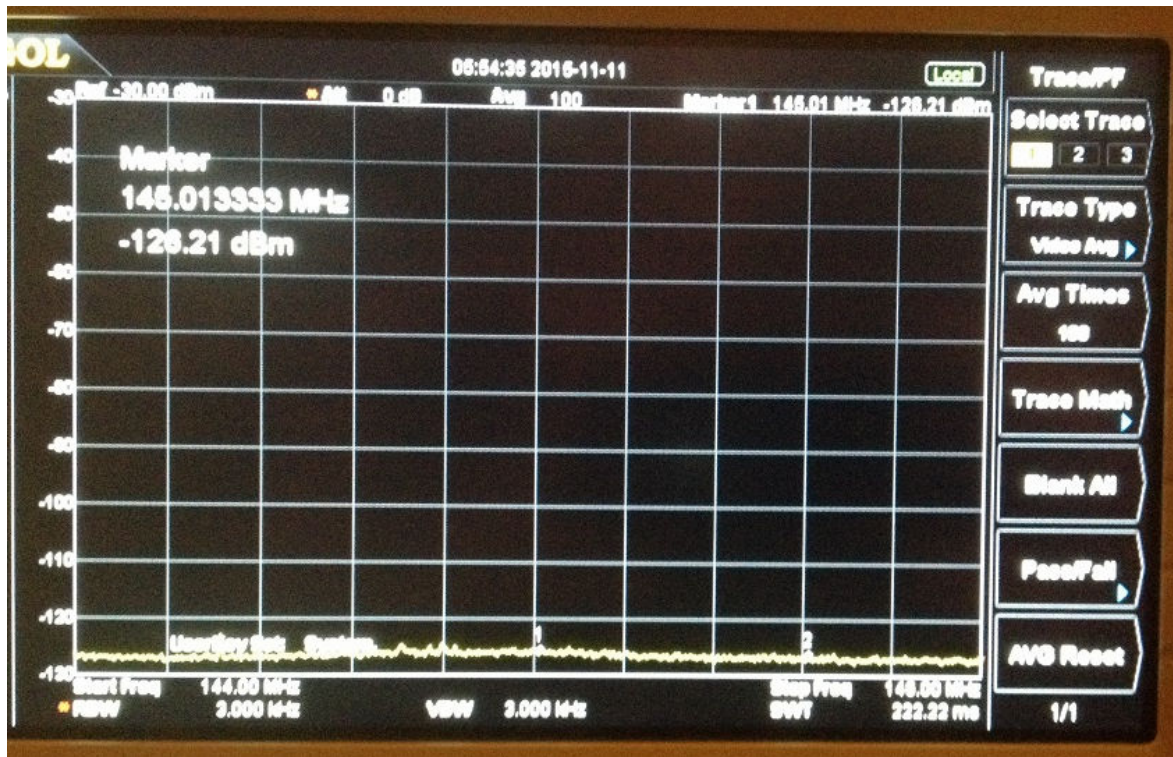
Antenna-TXOFF.JPG: Turning off the TX signal completely removes the noise floor and also the fixed peaks
