Step Attenuator Repair

Attenuator Repair For HP/Agilent Microwave Equipment

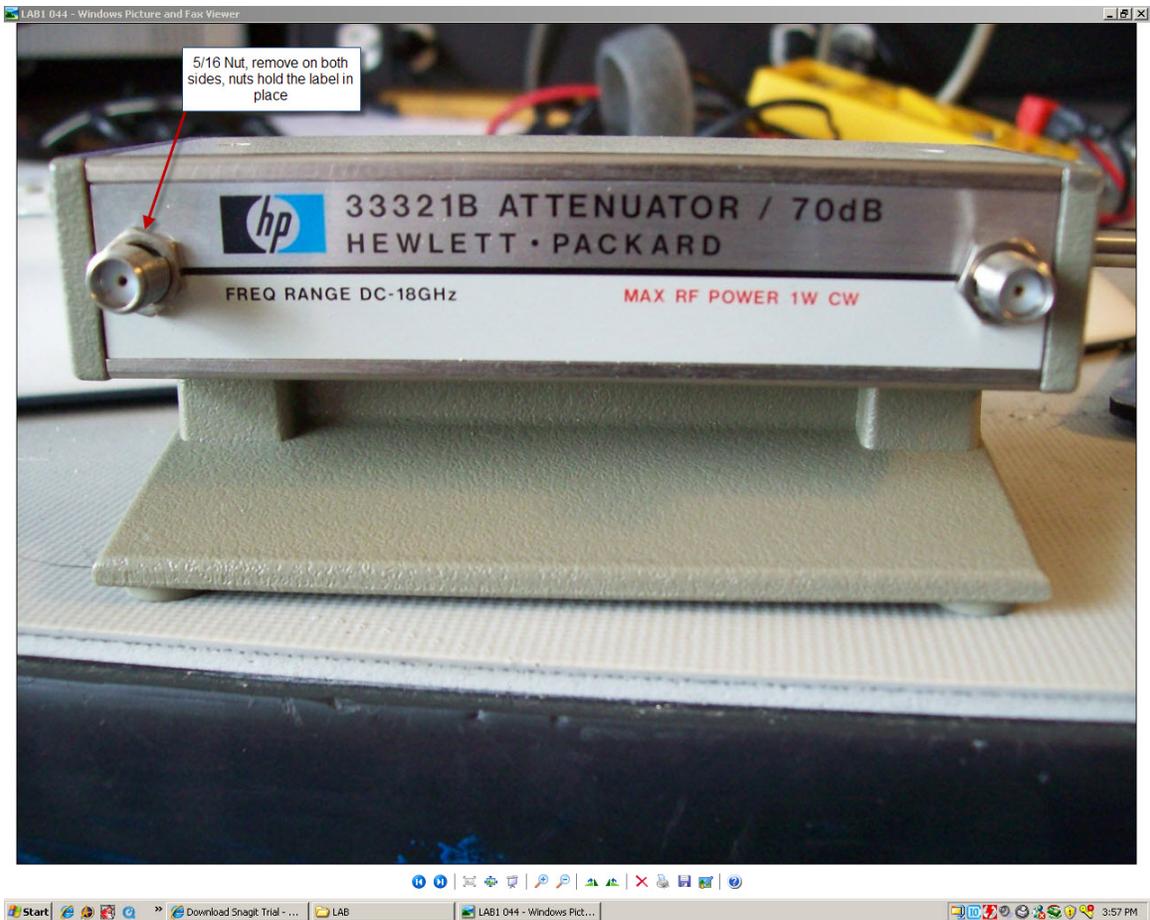
Picture showing the location of the holding nuts for the nameplate, the nameplate has to be removed to gain access to the socket screws that hold the RF Cover in place !

Now let's take the attenuator apart, looking at the top you will see a nut on each SMA connector, remove this nut this will allow for you to remove the nameplate, under the plate you will see a wealth of Allen screws, remove those but note that the screws close to the SMA connector are shorter than the other ones.

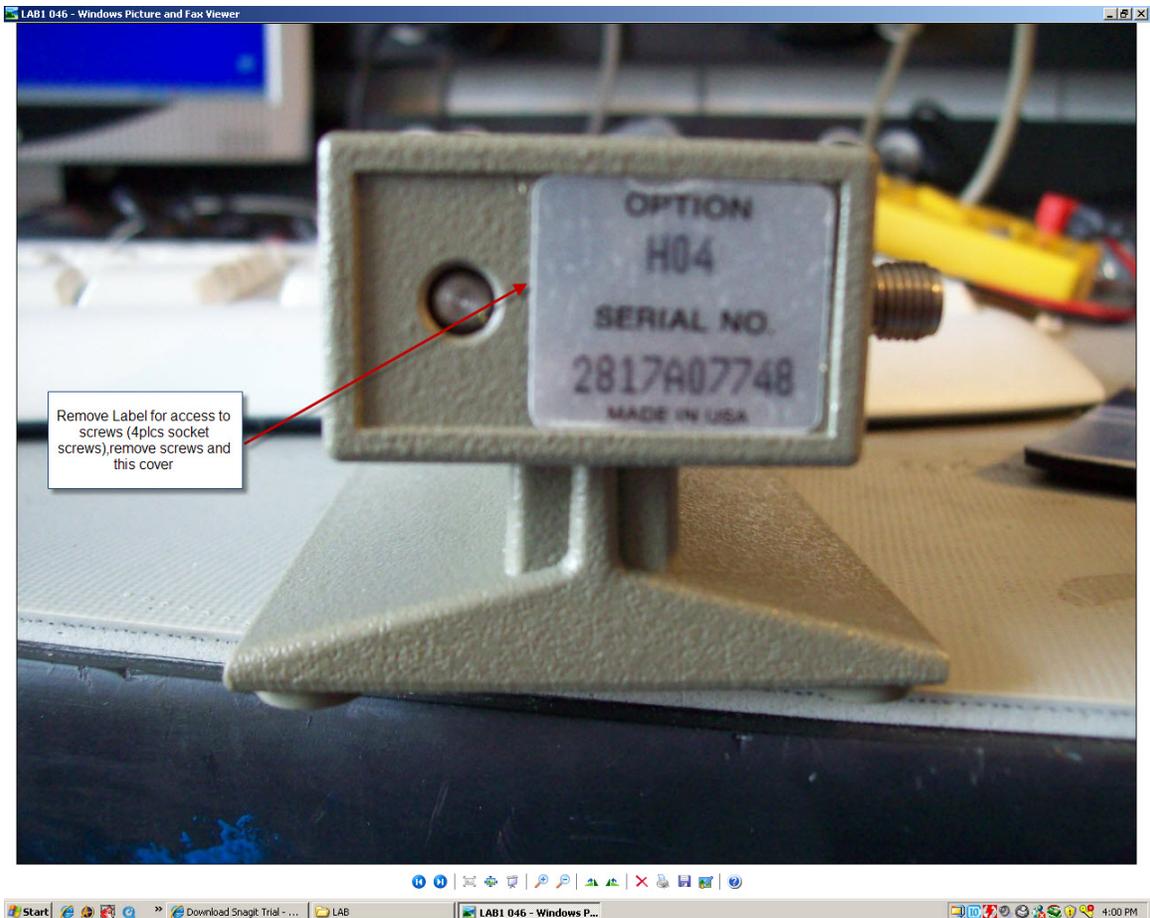
The Screws holding the side panel in place are covered by this label, this label needs to be removed since removal of the side panel is essential in order to be able to remove the other covers !

Now look at the small sideplate, not the one with the ribbon cable but the other side - there are 4 small Allen screws, remove those and then remove the sideplate. Be careful not to lose the little wire mesh here ! now slide out the U shaped cover and remove the top side.

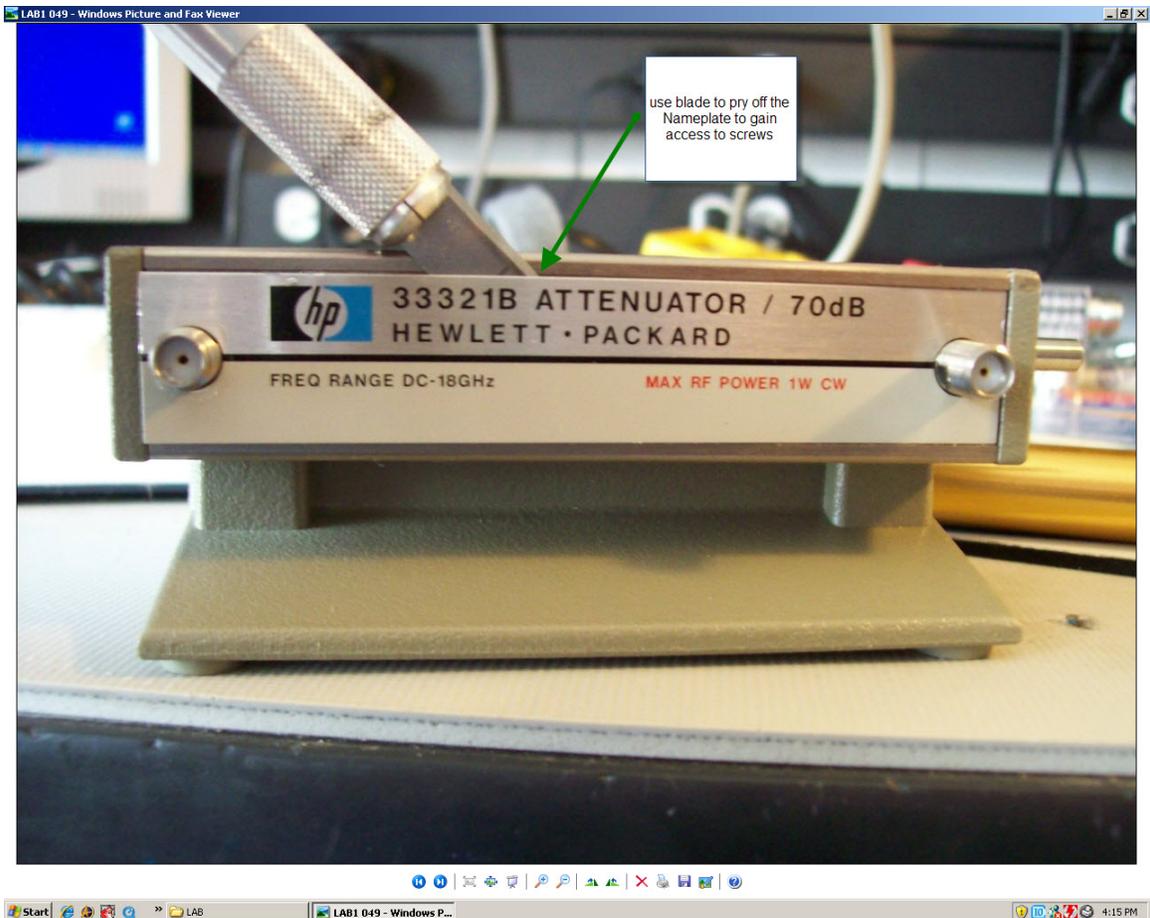
The 2 5/16 nuts have been removed and the nameplate can now be pryd off using a utility knife !

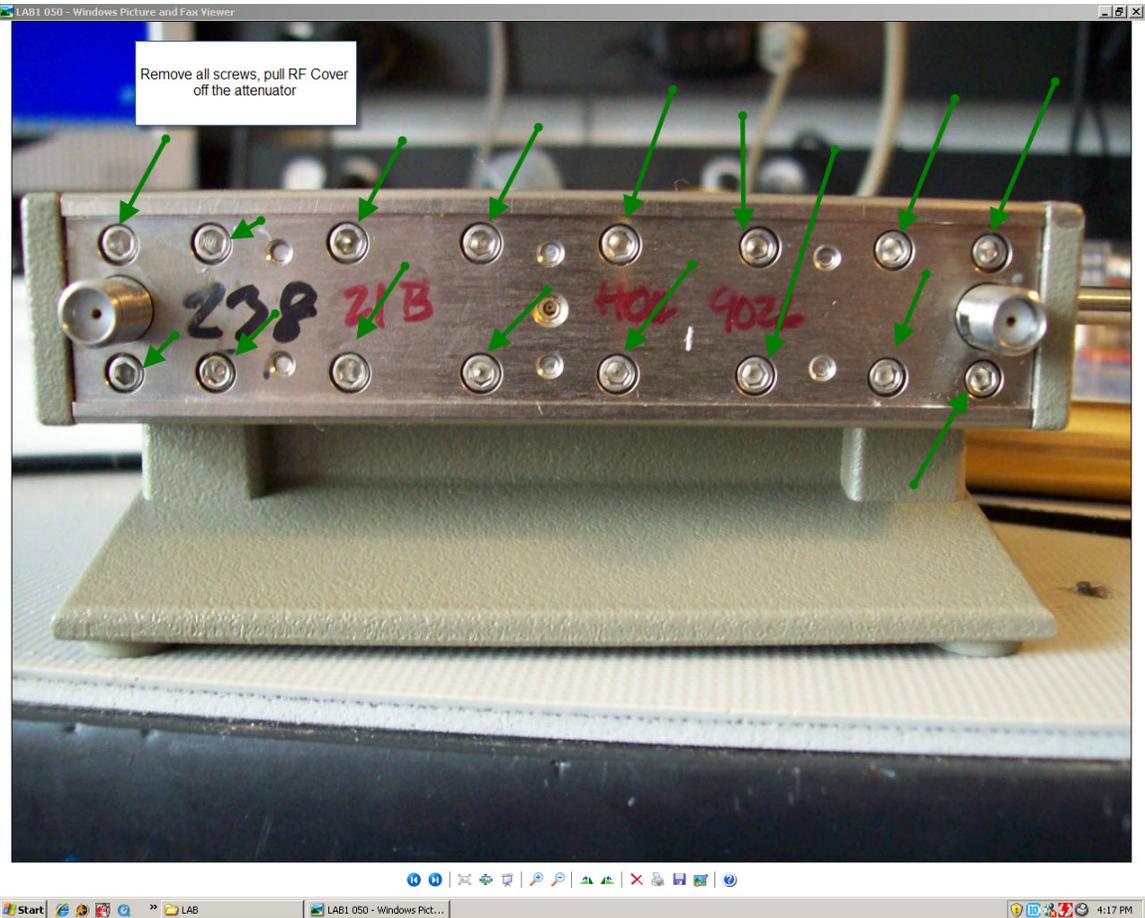
The screws holding the RF Cover are now visible and can be removed, please note that the screws above and below the SMA connectors usually are shorter in length to avoid interference with the screws holding the side panels !

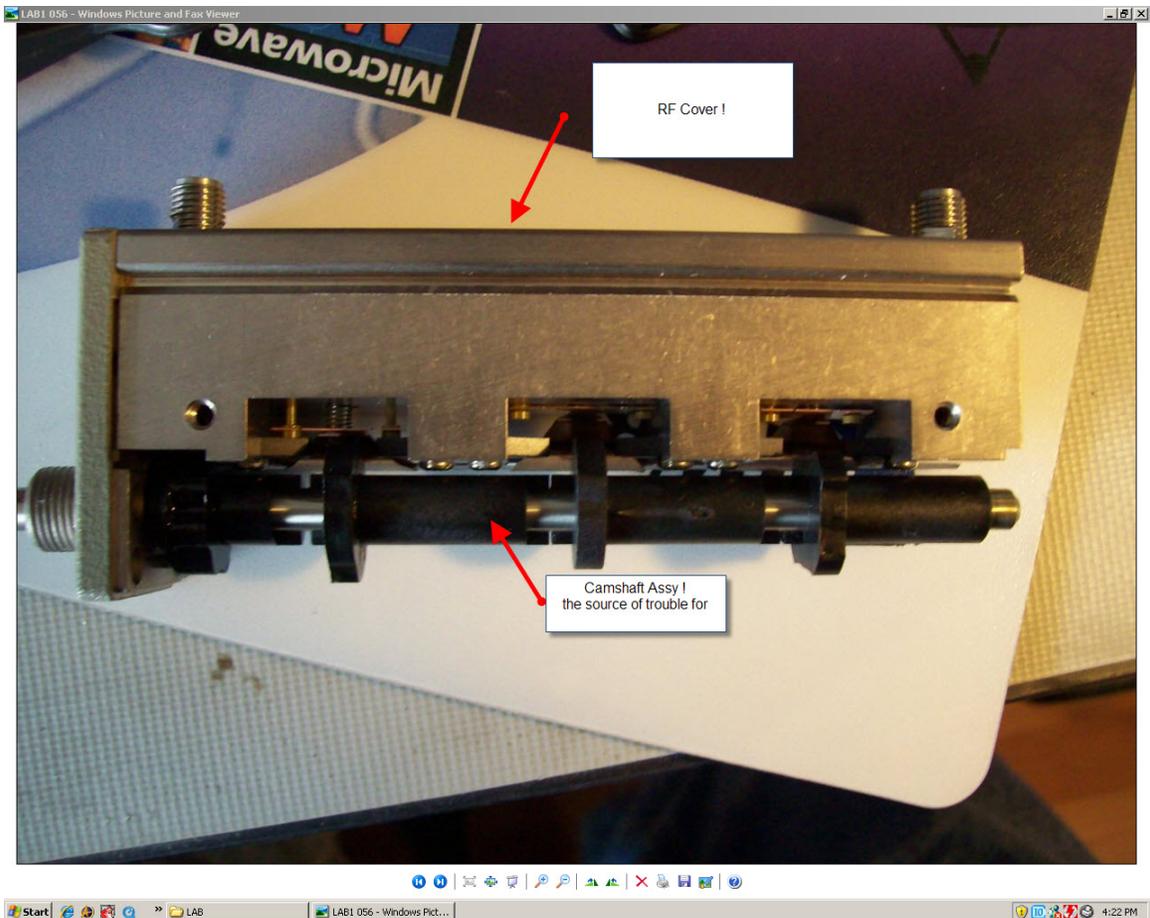
Side view showing the RF Cover and camshaft assembly, the camshaft wears out over time which causes failures, the RF cover holds the attenuators.

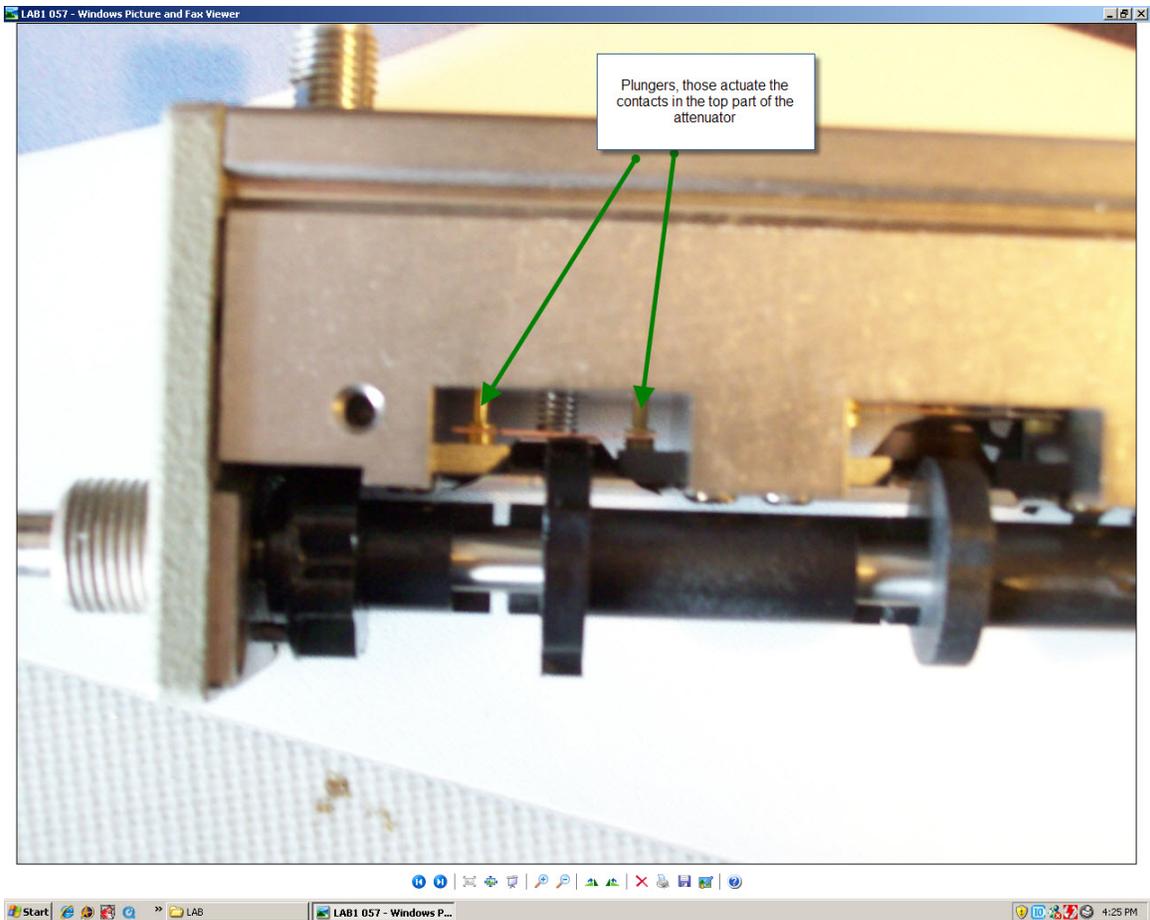
The plungers actuate the contacts, manual and programmable step attenuators use different type of plungers !

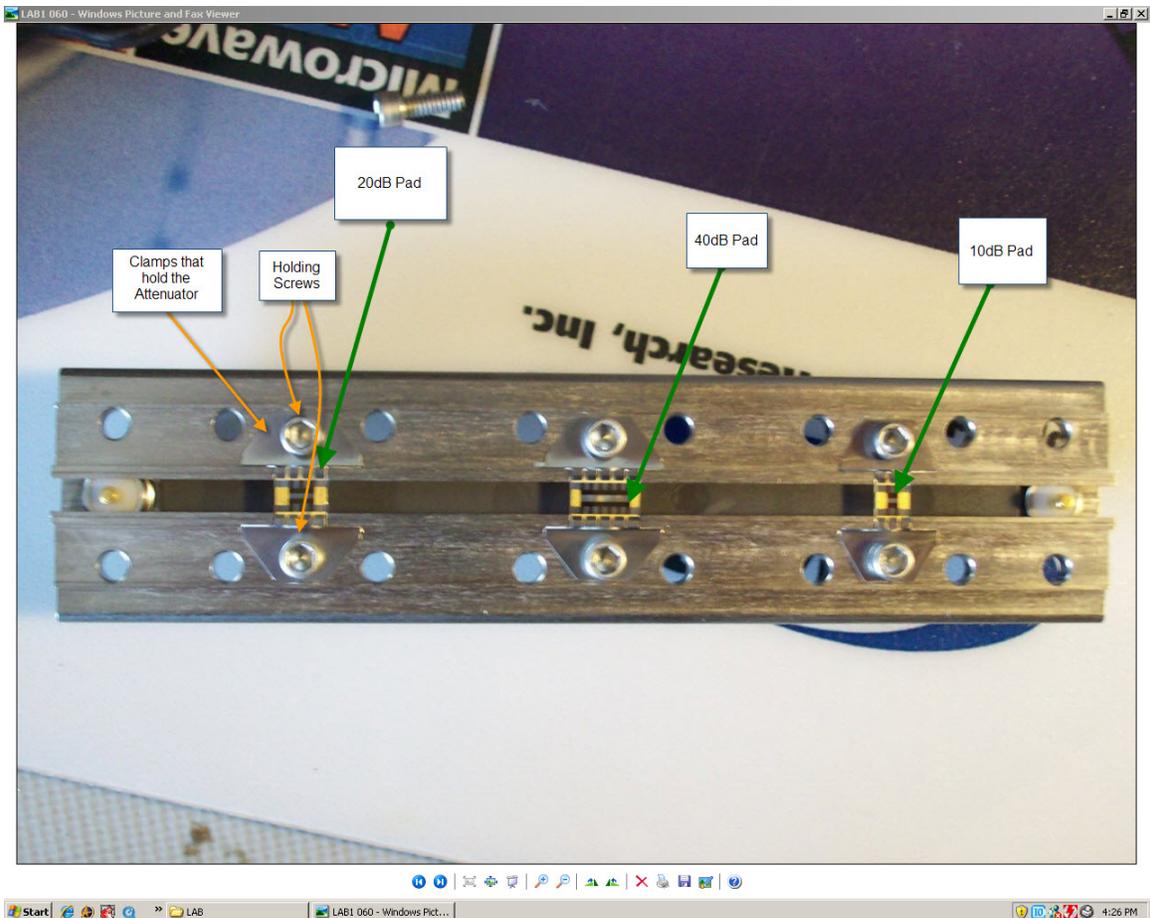
The RF cover, you can see the pads as well as the holding screws and clamps that hold the attenuators in place, the attenuator pads can be checked with a DVM and should measure about 50ohms to ground from the gold pads, this however does not apply to the 10Db pad which normally measures higher !
Also inspect the pads for cracks which is a common failure mode.

First lets inspect the pads, you can measure them with an ohm meter, they should measure in the vicinity of 50 ohms , except of the 10dB pad which can measure up to 70 ohms or more.

Inspect the pads visually, are there any burned or cracked pads? If all pads look OK and check out at DC, take a surgical swab and isopropyl alcohol and carefully clean the contact pads on the attenuators.

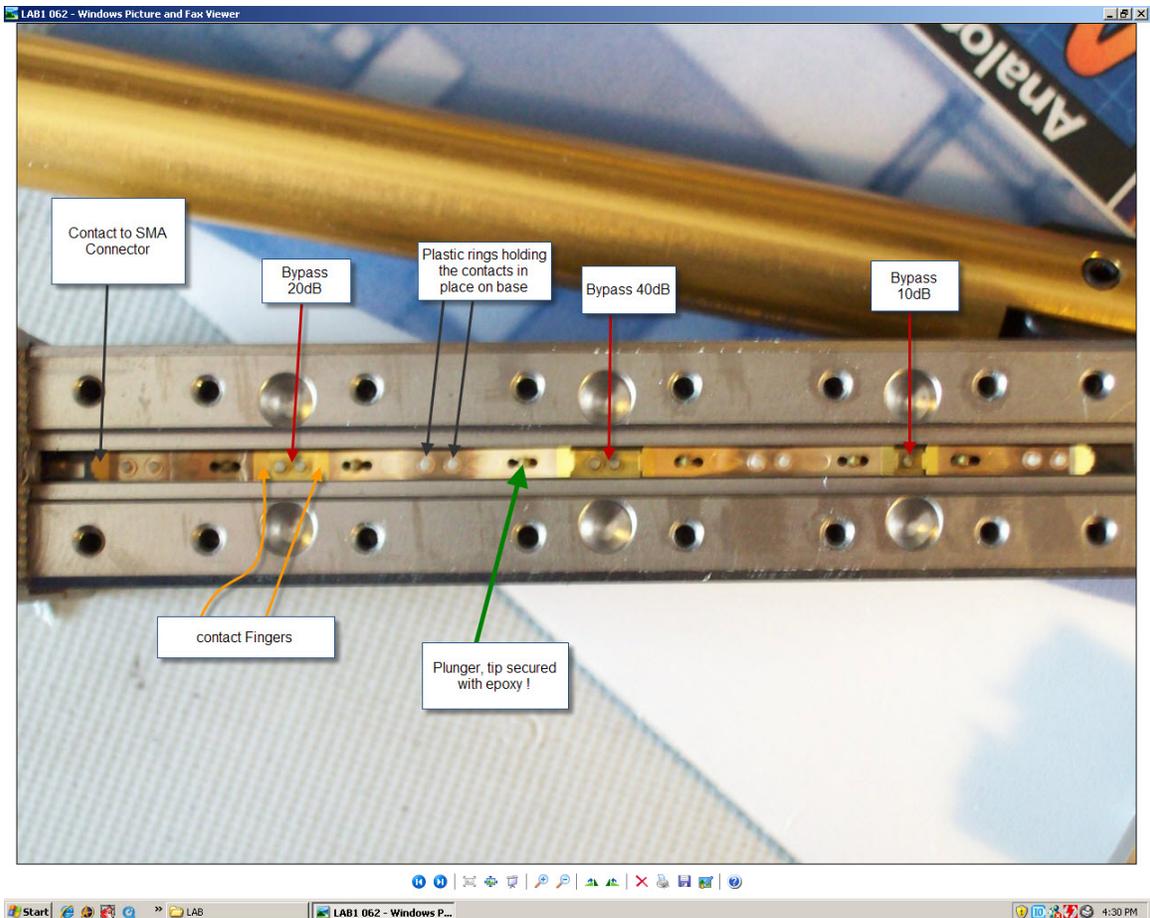
This picture shows the contacts and bypass for each Attenuator cell, bypass and contacts are mounted on a base made out of plastic which can be replaced, also visible here is the tip of the plunger which is secured with epoxy

Next look at the contacts. Enable all solenoids and observe the position of the contact tongues, they should be slightly above the surface of the block. Carefully clean the contact tongues with alcohol, be careful not to bend them.

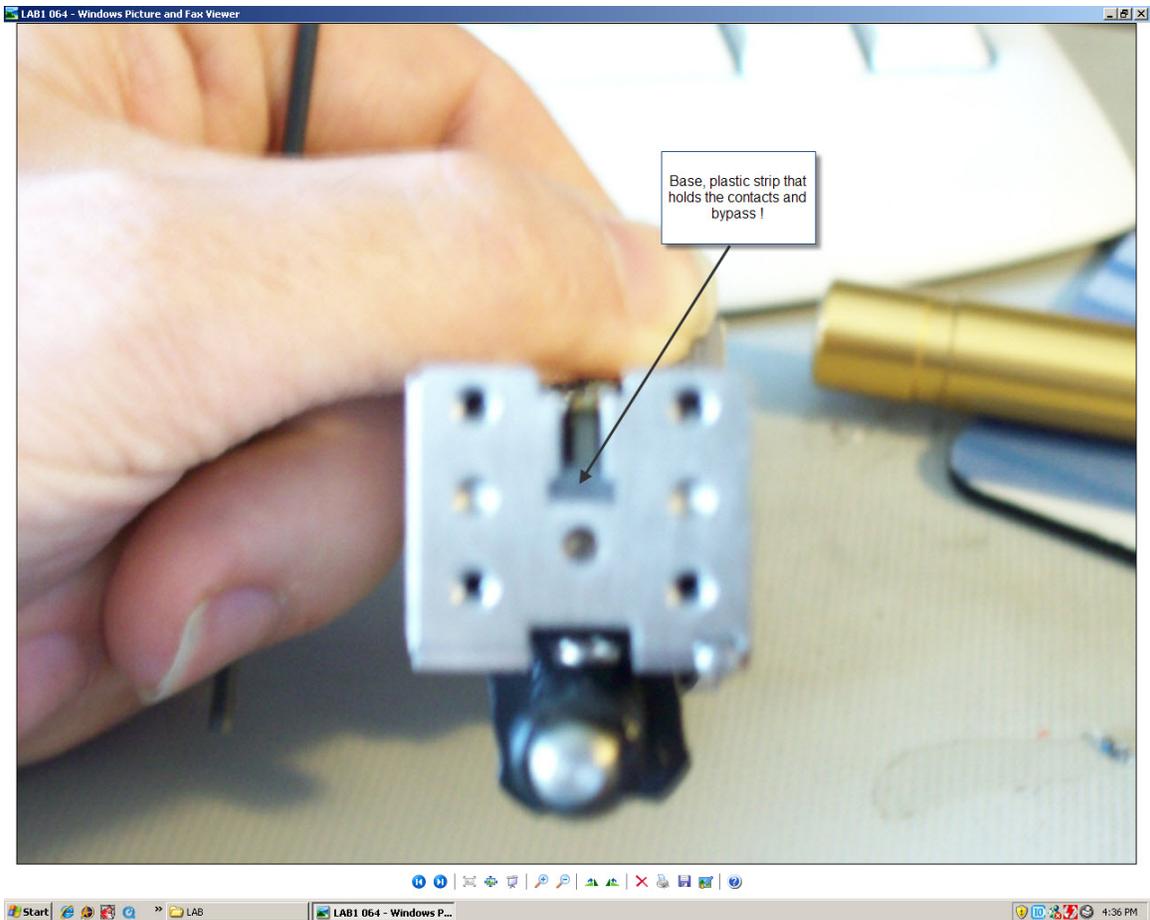
Side view shows the base, once all plungers have been removed the base slides out to the side of the attenuator allowing access to the bypass and contacts.

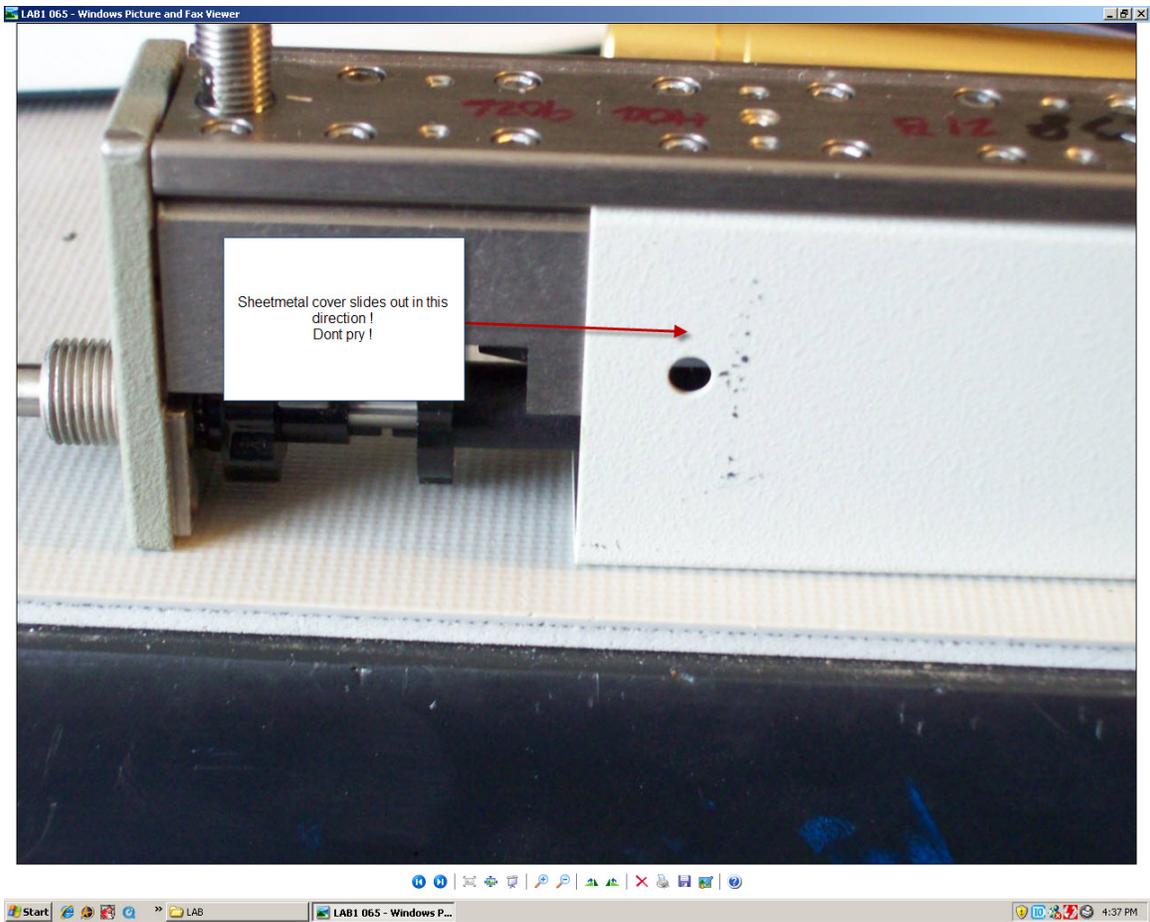
The cover slides out to the side, this is the proper way to do it folks !

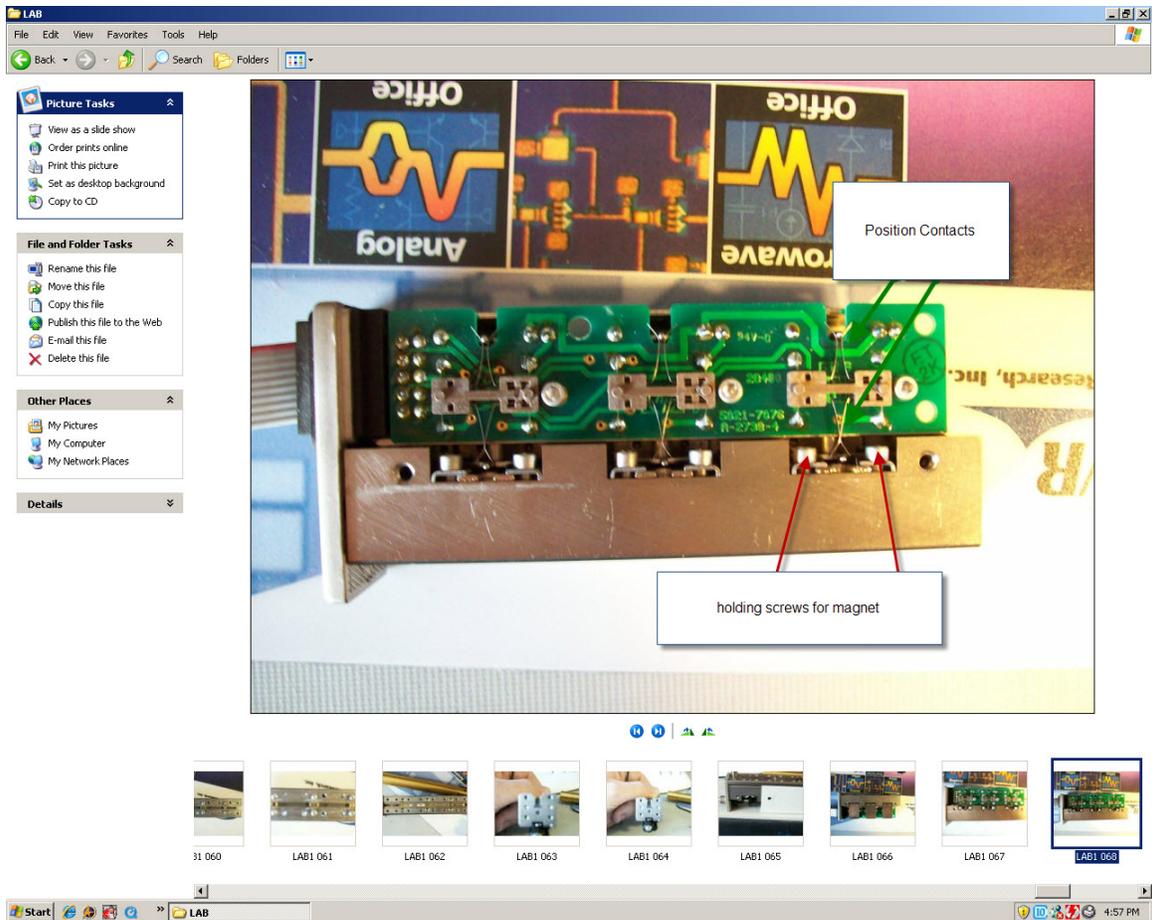
A programmable attenuator, visible are the holding screws for the magnet as well as the contacts that turn the solenoid off once the switching has been completed, the little prongs that actuate the contacts are supposed to have a plastic sleeve over them, pay attention to this when you open a attenuator as missing sleeves are a common failure mode

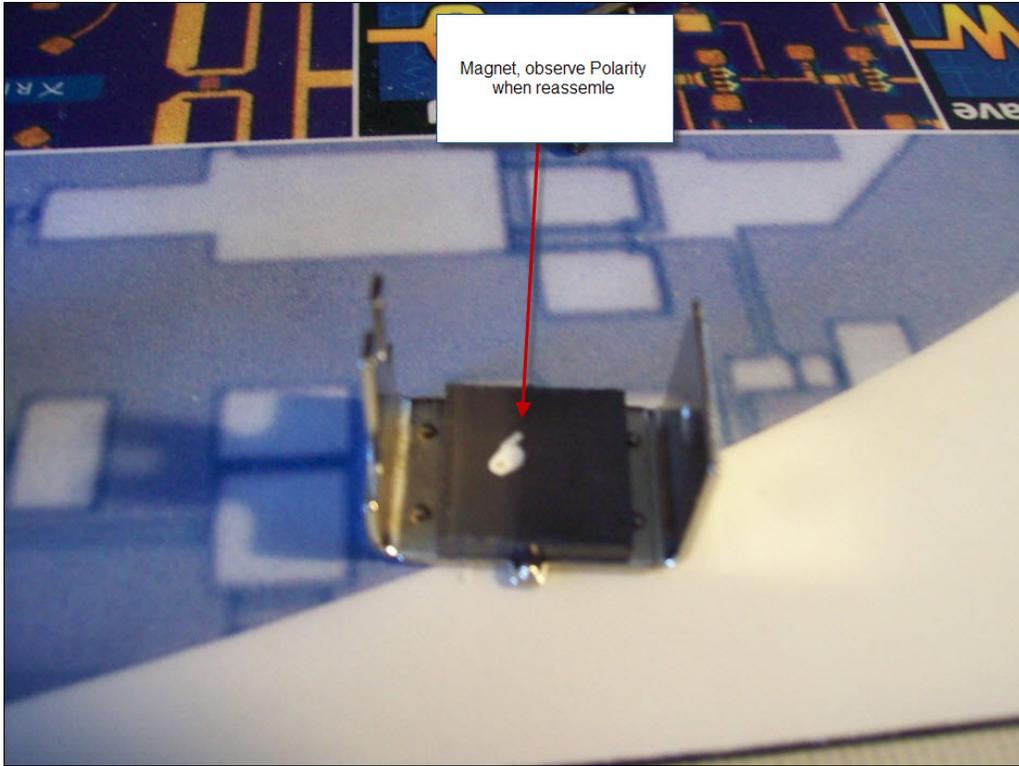
The magnet removed, please note the polarity of the magnet during dis and reassembly

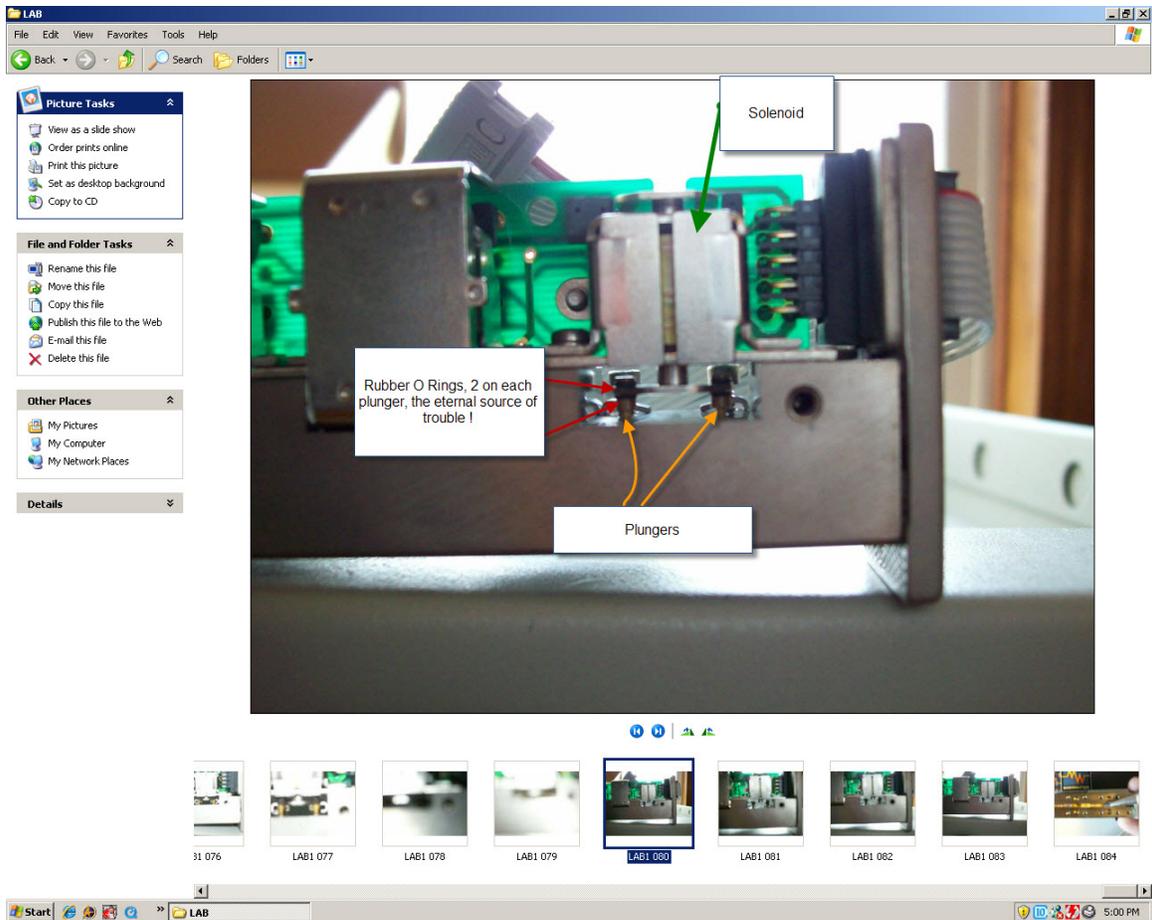
This picture shows the solenoid as well as the plungers , the o rings are not clearly visible in this picture but there are 2 on each plunger, missing or deteriorated O-Rings account for 75% of all step attenuator failures !

Plungers can be removed by using a needle or pointy knife , use it to push the tip of the plunger over and down until its free from the contact, during re assembly you will use it to push the tip over to align it with the mounting hole in the contact.

Next put the solenoids back into the 0 position and look at the top of the solenoids. You will see two little white plastic rods. Where those meet the solenoid you should see little rubber rings, there are 4 of those on each segment, usually over the years they go brittle and then disappear. With those rings gone the attenuator wont make contact anymore, you can buy the rings from watchmakers supply stores as they are being used for sprocket gaskets !

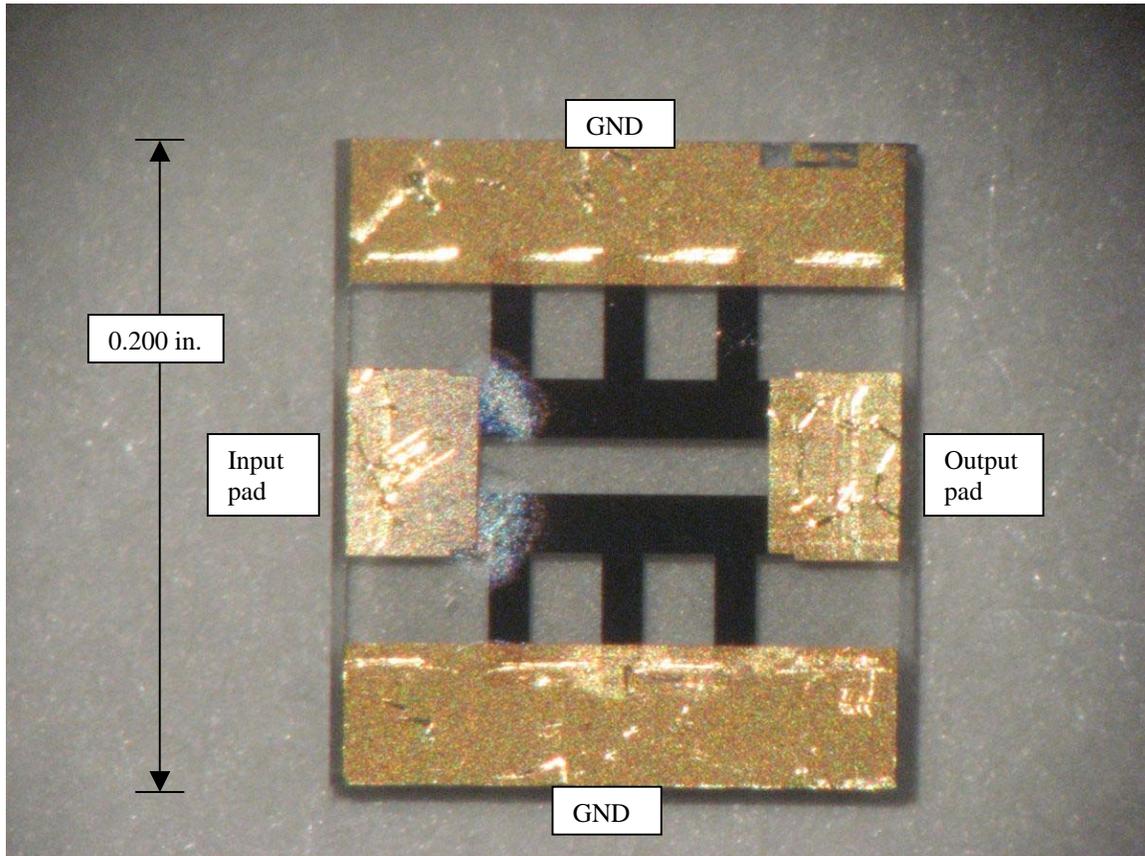
Defective 20 dB attenuation pad. Shows infinite resistance to gnd on input pad. Probably blown by excessive power at input pad.

If you have a broken or burned pad, don't stress over it. The pads are used in all HP attenuators so just find a similar attenuator on ebay and take the pad you need out of it, you can also buy pads from Agilent however be prepared to pay \$100-150 per piece

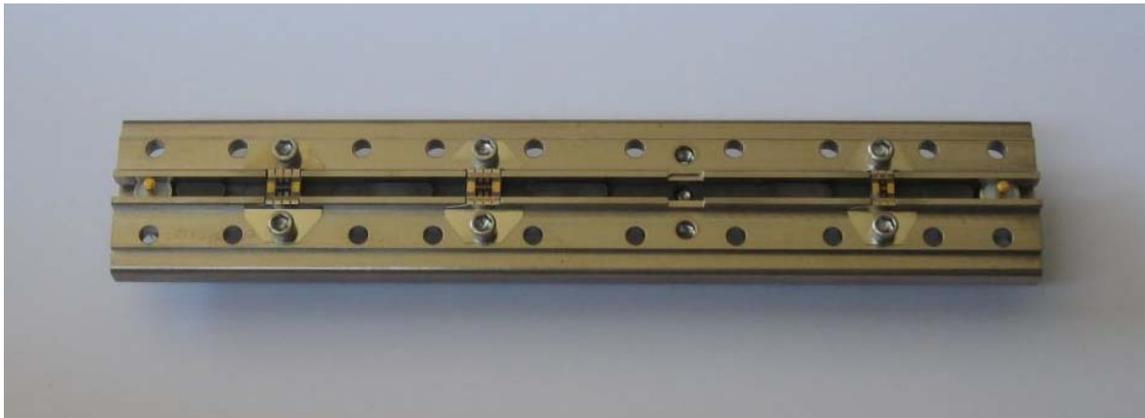
Pad carrier. Third pad is missing. The fourth pad is 10 dB. It is shorter. The SMA connectors are at both ends.

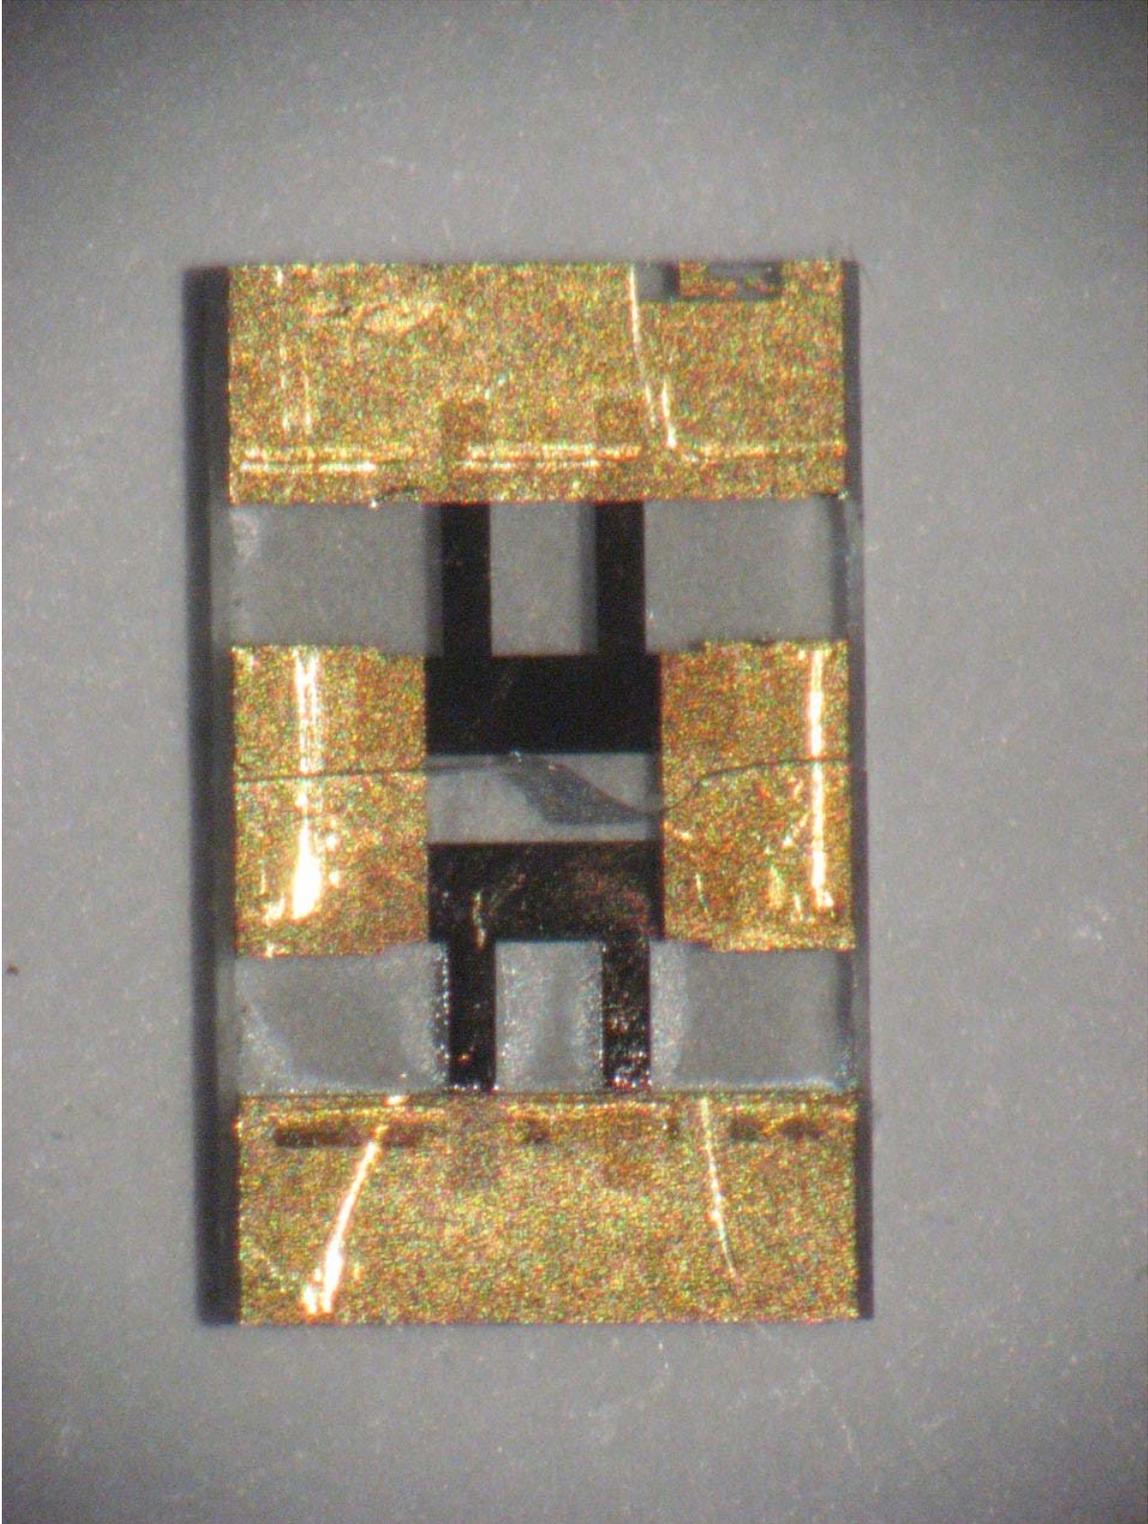
Defective 10 dB attenuation pad. Notice the crack in the glass substrate. The bottom side seems to have overheated.

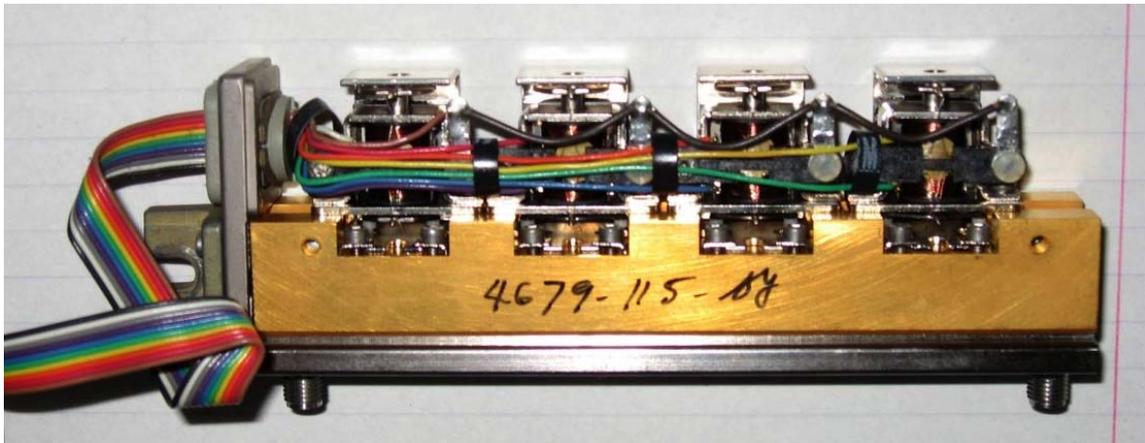
View of attenuator after removing shield.
